April 1981

## Cost-Reduced M587 Electronic Time Fuze: Root Cause Analysis of July 1979 Early Bursts

by Norman J. Doctor

U.S. Army Electronics Research  
and Development Command  
**Harry Diamond Laboratories**

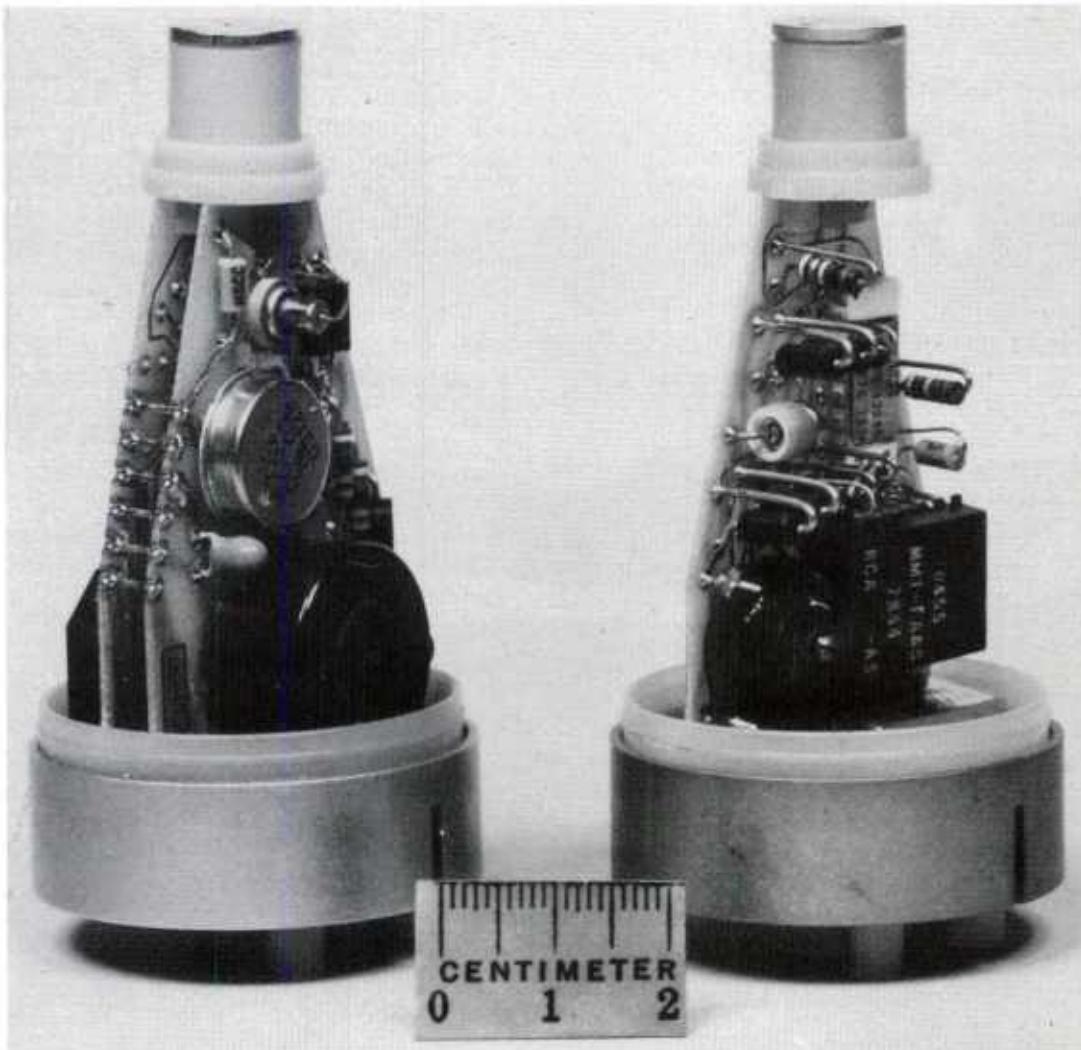
Figure 3. E-heads.

It can also be seen in figure 3 that many of the discrete components in the new single-board E-head are mounted upright on the board rather than flat as is the case with the type-classified two-board E-head. This upright mounting is one of the factors which permitted a single-board design because it conserves board space.

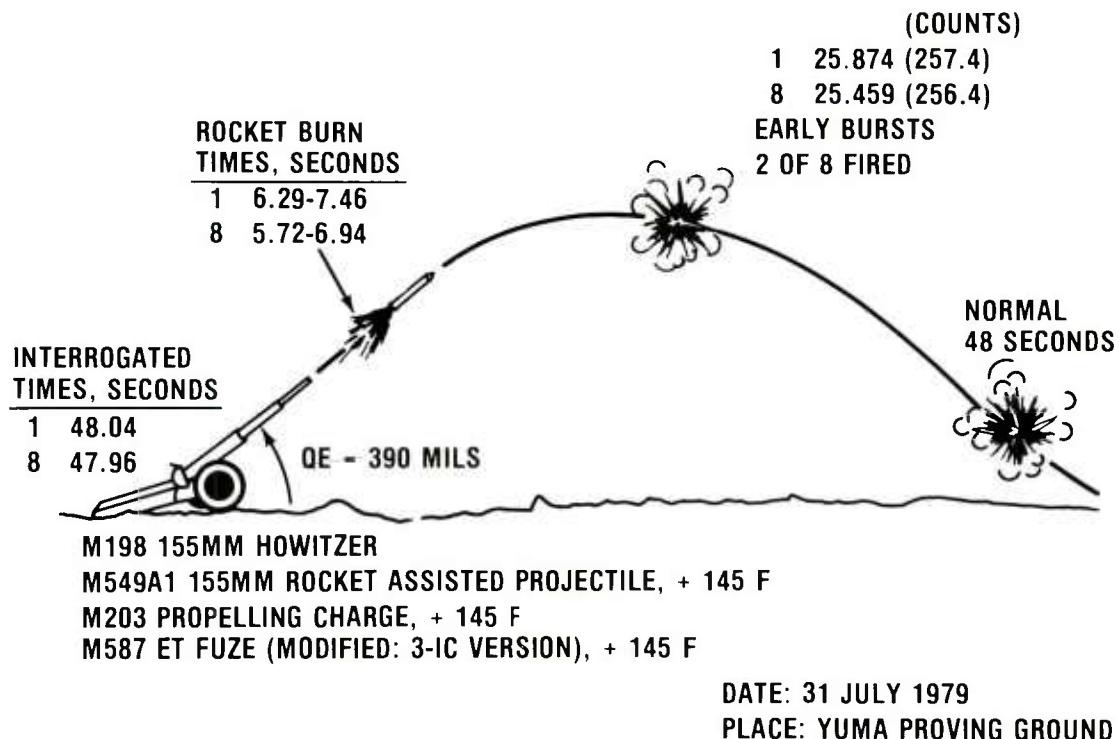
The early bursts are pictured in figure 4. Shown in the figure are the interrogation times of the fuzes, rocket-on and rocket-off times, and times of the early bursts. The rocket and early-burst times were obtained from tapes of the HAWK radar which tracked all rocket-assisted projectile firings.

Figure 4. Pictorial representation of early bursts.
